DEPARTMENT OF TRANSPORTATION

Contract #: 04-0120F4Cty: SF/ALA Rte: 80 PM: 13.2/13.9File #: 69.28**WELDING INSPECTION REPORT****Resident Engineer:**Pursell, Gary**Address:** 333 Burma Road**City:** Oakland, CA 94607**Report No:** WIR-001409**Date Inspected:** 02-Feb-2008**Project Name:** SAS Superstructure**OSM Arrival Time:** 700**Prime Contractor:** American Bridge/Fluor Enterprises, a JV**OSM Departure Time:** 1530**Contractor:** Zhenhua Port Machinery Company, Ltd (ZPMC), Changxing Island **Location:** Shanghai, China**CWI Name:** See Below**CWI Present:** Yes No**Inspected CWI report:** Yes No N/A**Rod Oven in Use:** Yes No N/A**Electrode to specification:** Yes No N/A**Weld Procedures Followed:** Yes No N/A**Qualified Welders:** Yes No N/A**Verified Joint Fit-up:** Yes No N/A**Approved Drawings:** Yes No N/A**Approved WPS:** Yes No N/A**Delayed / Cancelled:** Yes No N/A**Bridge No:** 34-0006**Component:** Tower and OBG Fabrication**Summary of Items Observed:**

Orthotropic Box Girder (OBG) and Tower Mock Up:

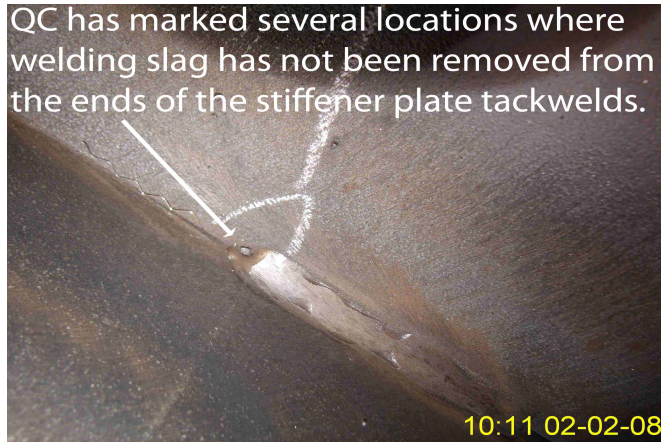
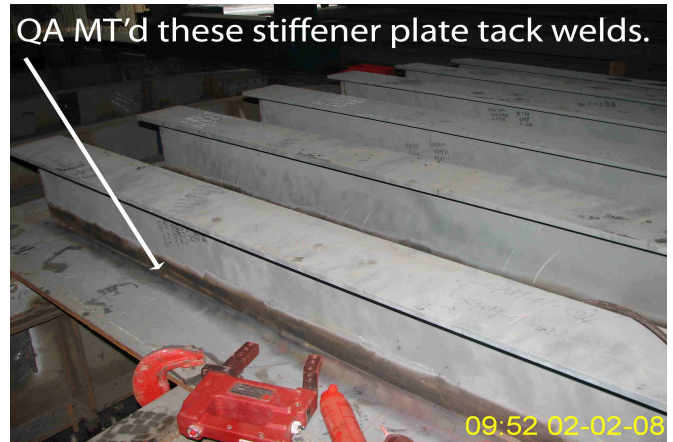
The QA Inspector performed random visual inspections and magnetic particle (MT) inspections of portions of OBG side plate SP019 stiffener fillet tack welds SP019-01-013 through SP019-01-023. The plate is clamped to a pre-camber table in order to minimize final weld distortion. ZPMC QC magnetic particle inspector Mr. Cai Xinxin had marked "MT OK" on the base material adjacent to where these tack welds are located. The welds that were MT inspected appear to comply with project specifications. QA Inspector visually observed several of these tack welds have small pieces of slag at the ends of the welds. The QA Inspector showed ZPMC QC CWI Inspector Mr. Xu Xianping one of these locations with the slag and Mr. Xu Xianping had the slag removed. Mr.

Xianping said he will visually inspect the remainder of the side plate tack welds to ensure no other slag is at the ends of the tack welds. The QA Inspector observed Mr. Xianping marked approximately ten locations where slag needs to be removed at the ends of the welds, and ZMPC personnel used a chipping hammer to remove the slag. See the photographs below for additional information.
